January 2010

Real-Time River Channel- Bed Monitoring at the Chariton and Mississippi Rivers in Missouri 2007–09

IBRD Sonar Scour Monitoring Project: Real-Time River Channel-Bed Monitoring at the Chariton and Mississippi Rivers in Missouri, 2007-09

by
Paul H. Rydlund, Jr.
USGS

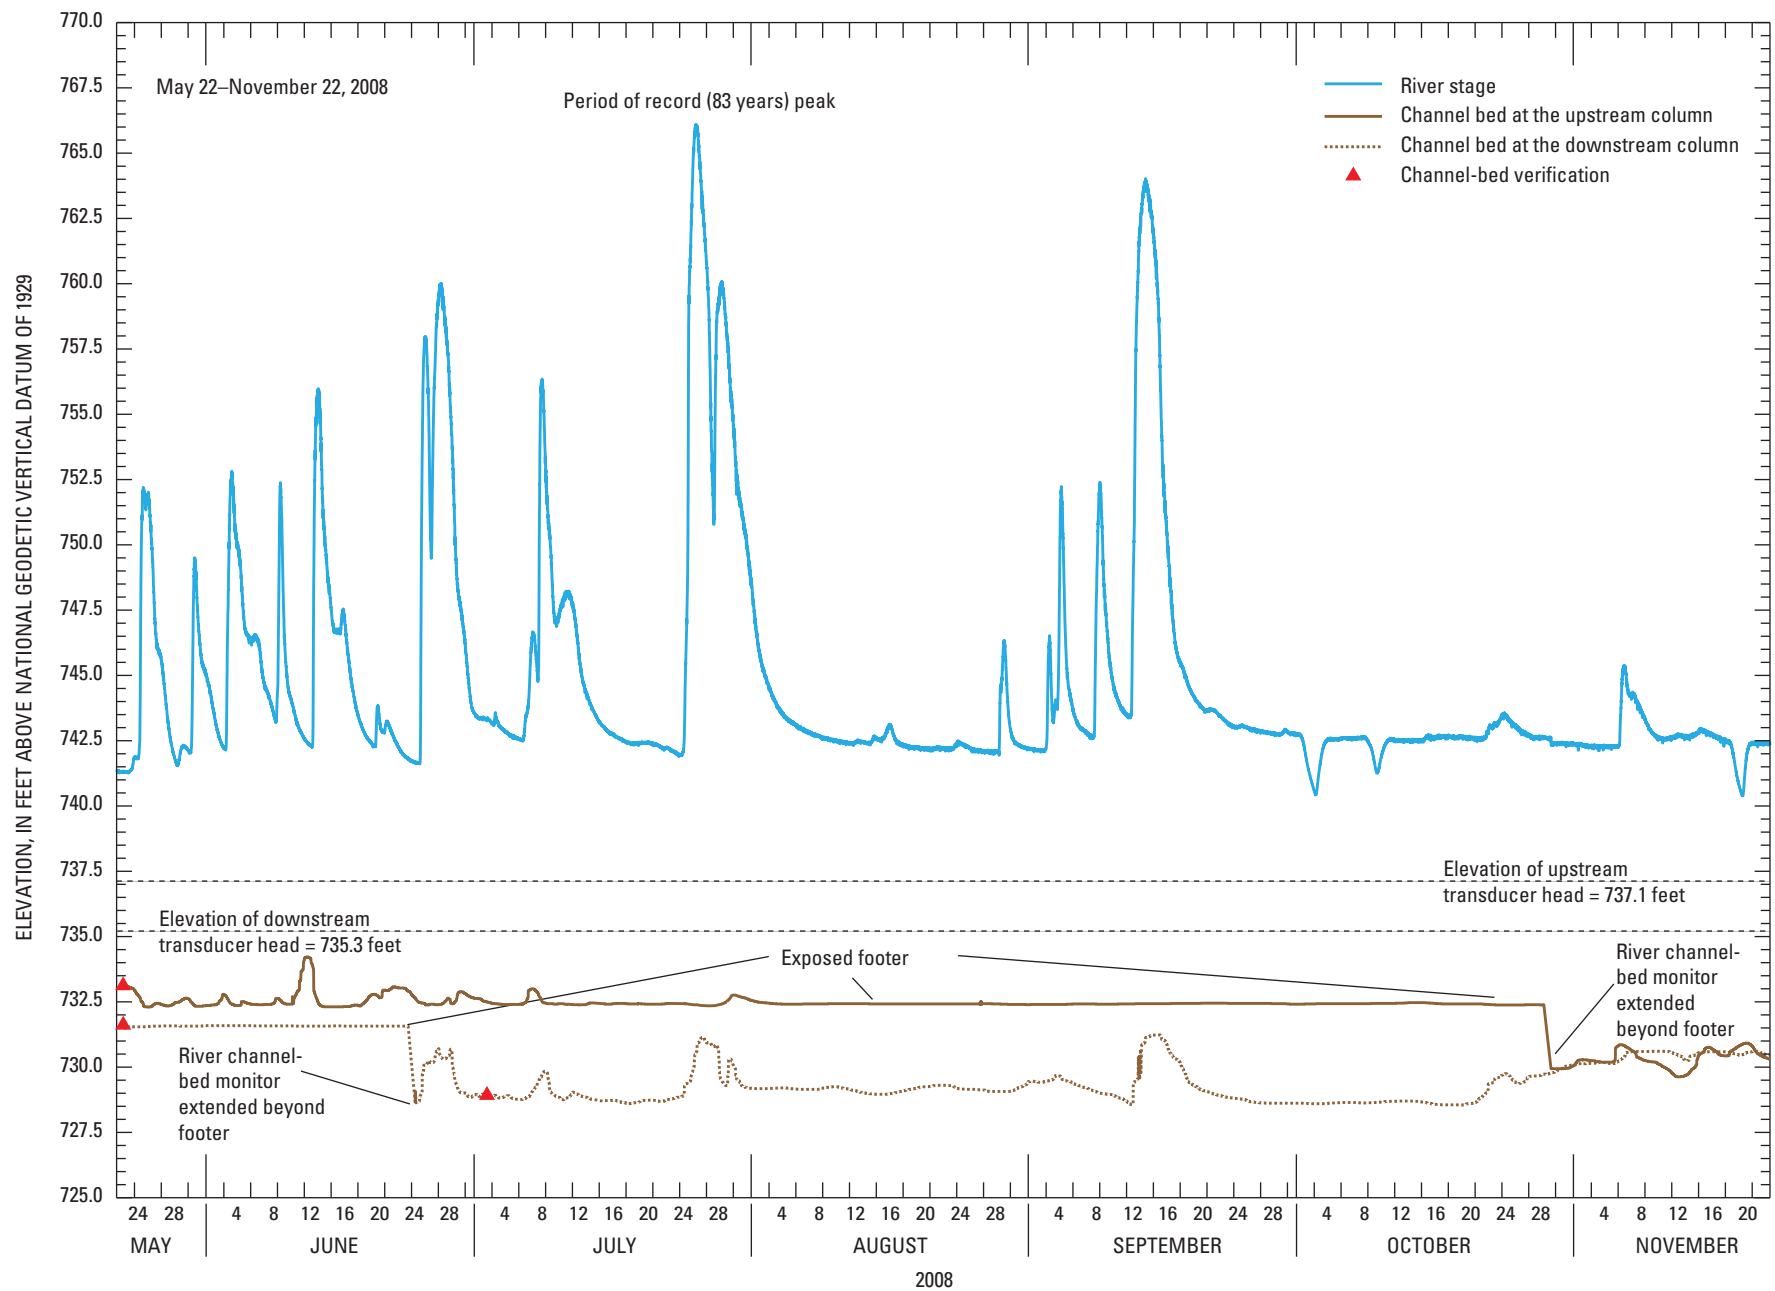
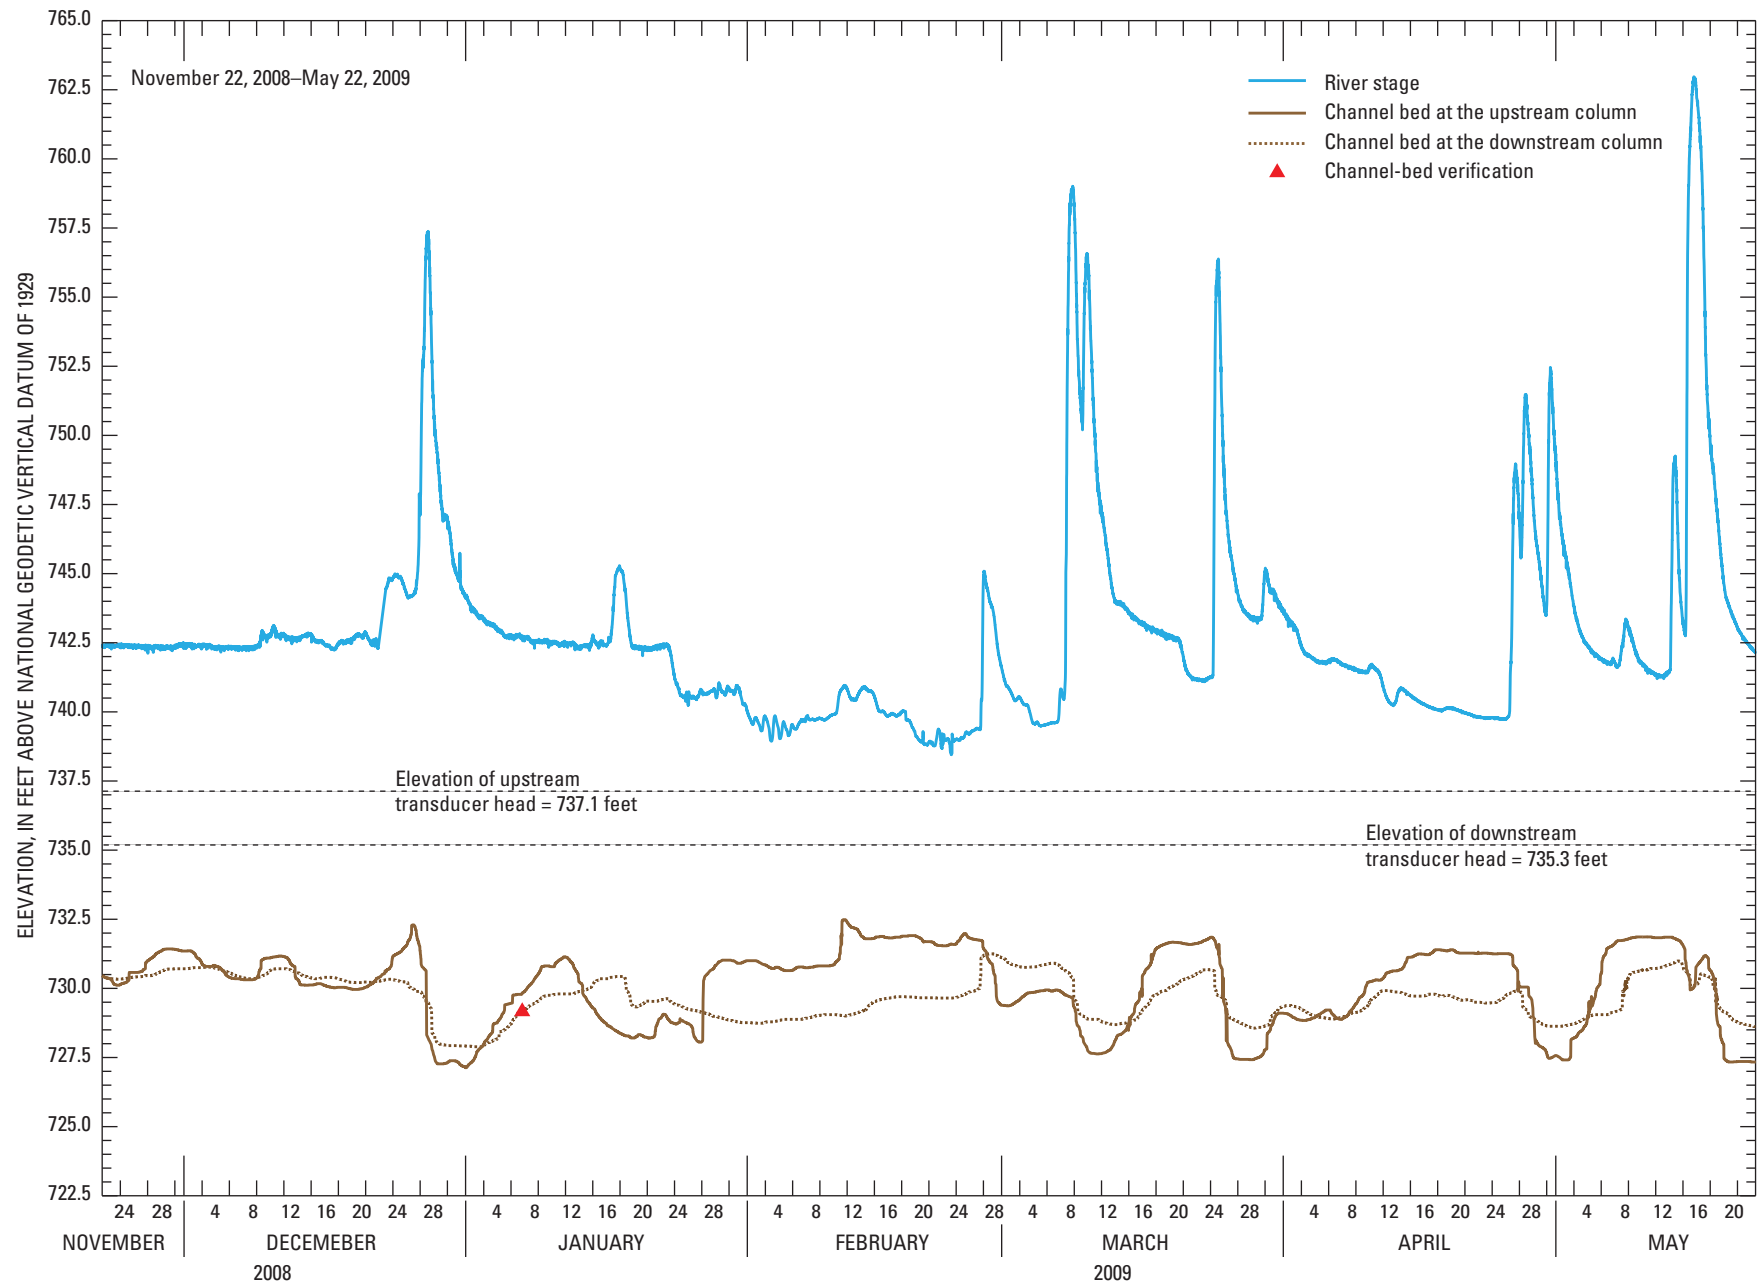
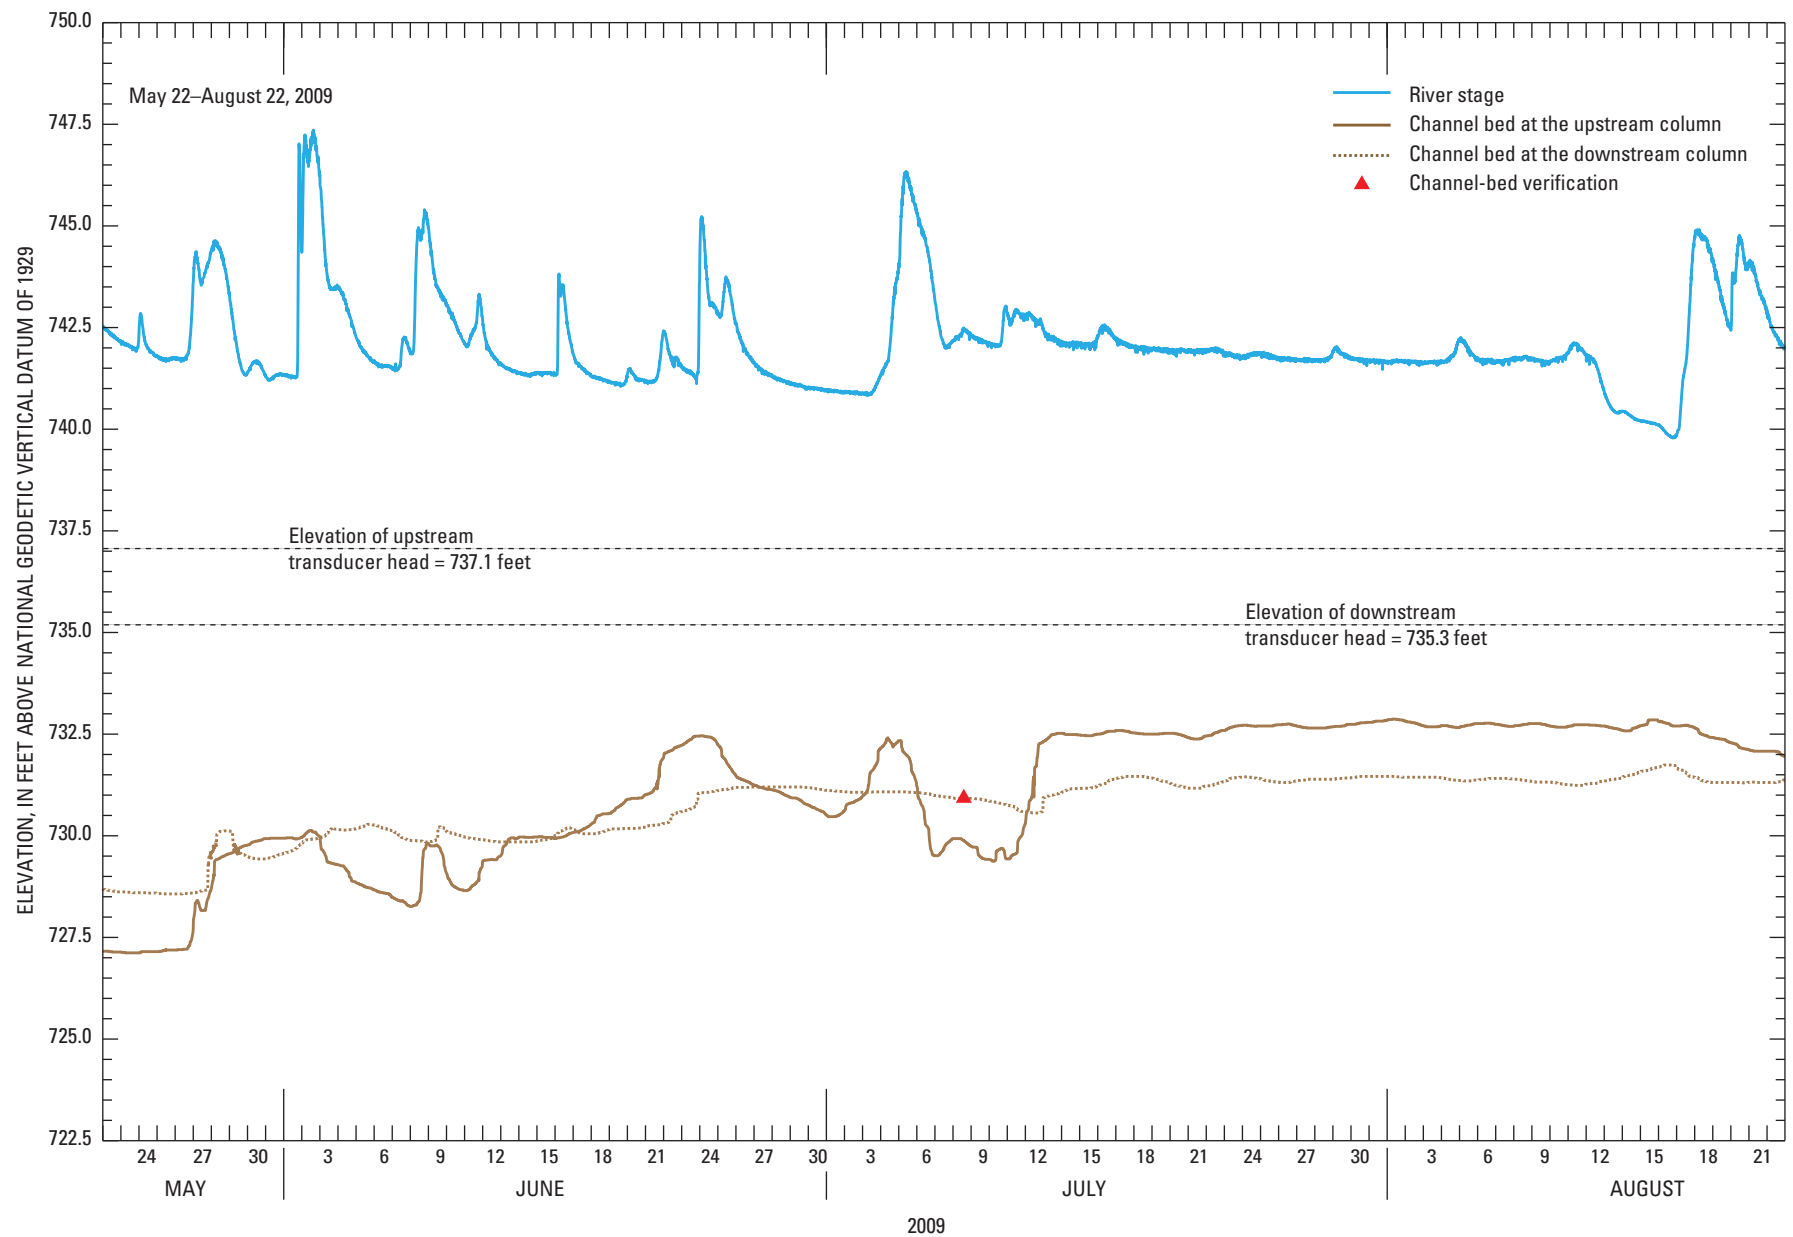
Figure 10. River channel-bed elevation at the downstream side of the upstream and downstream columns of pier 7 and river stage from May 22, 2008, through August 22, 2009, for the Chariton River at Novinger, Missouri (structure L-534).

On May 22, 2008, RCBMs were installed on the downstream side of the upstream and downstream columns of pier 7. After the installation, the channel-bed record appeared to be depicting bed changes for the upstream column (fig. 10), but progressively became steady and flat, indicating exposure of the footer behind the upstream column. After the installation of the RCBM at the downstream column, the RCBM was sounding the footing. The transducer head was moved beyond the footer an additional foot (extended from 2 to 3 feet) at both upstream and downstream columns to ensure adequate sounding of the channel bed (fig. 10).

The downstream channel-bed record depicted an elevation of 731.5 feet, which was within 0.2 foot from the elevation of the top of the footer of 731.7 feet, as indicated from MoDOT bridge plans. As bed monitoring continued at the downstream column from May 22 through November 22, 2008, depositional responses to hydrologic events occurred near the end of June, end of July, and middle of September. A period of record peak flood event of 30,200 cubic feet per second occurred July 25, 2008, and was the largest recorded flood in 83 years of record, with a statistically defined annual exceedence probability between 2 to 4 percent, or in the range of a 50- to 25-year recurrence (Robert Holmes, U.S. Geological Survey, written commun., 2009). The RCBM at the upstream column revealed an exposed footing, but the channel-bed record at the downstream column did not indicate any substantial response to the magnitude of this peak (fig. 10). Channel-bed monitoring at the downstream column indicated channel-bed changes as large as 3 feet and difficulty in ascertaining the presence of bedforms from May 22 through November 22, 2008. For the same period of time, the footer at the upstream column was progressively more exposed, which was made apparent by a steady and flat channel-bed signature during July through October. Channel-bed fluctuations at the upstream column were as much as 1.5 feet before the footer was exposed and after the transducer was moved during this period.

During November 22, 2008, through May 22, 2009 (fig. 10), RCBM data at both upstream and downstream columns were examined for correlation with hydrologic events. Channel-bed scouring at both upstream and downstream columns appeared to be a response to increasing velocities associated with rising limbs of hydrologic events occurring December 22, 2008, March 8, March 24, April 27, and May 16, 2009 (fig. 10). A subtle time lag appears to be evident between event-related scouring from the upstream to downstream monitoring locations. Overall, channel-bed elevation changes were as much as 5 feet at the upstream column and 3 feet at the downstream column. Although bedforms may be “concealed” as they contribute to the scour and deposition processes observed, a distinguishable bedform is evident at the upstream column during inter-event flows in late January and through the month of February. During the latter part of February to the beginning of March, the transition (occurring February 26) of a bedform, as depicted from the upstream monitoring location to the downstream monitoring location, may be apparent (fig. 10).

During May 22 through August 22, 2009, channel-bed changes as large as 6 feet occurred at the upstream column, and changes as large as 3 feet occurred at the downstream column (fig. 10). An inter-event flow period occurred July 12 through August 12, 2009, for which there was no channel-bed change or potential bedform movement. Hydrologic events occurring earlier in this data collection period (May 22 through August 22, 2009) demonstrated channel-bed responses that were atypical compared to scour and depositional responses observed from November 22, 2008, through May 22, 2009 (fig. 10).
